HONDA

93V-056 (U)

Honda will recall and replace the sensor in the rear seat belt retractor of 1991, 1992 and early production 1993 Accord station wagons free of charge.

Replace both rear seat belt retractor sensors with the new sensors included in the kit listed under PARTS INFORMATION.

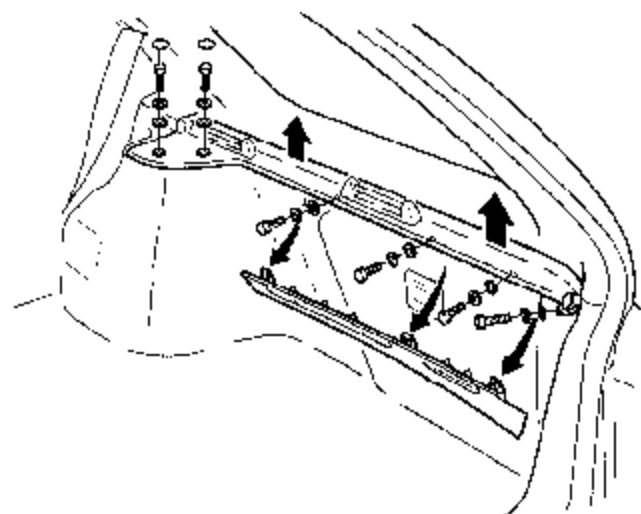
3. Remove the side rail trim (three clips). Remove six 6 mm bolts; then remove the side rail.

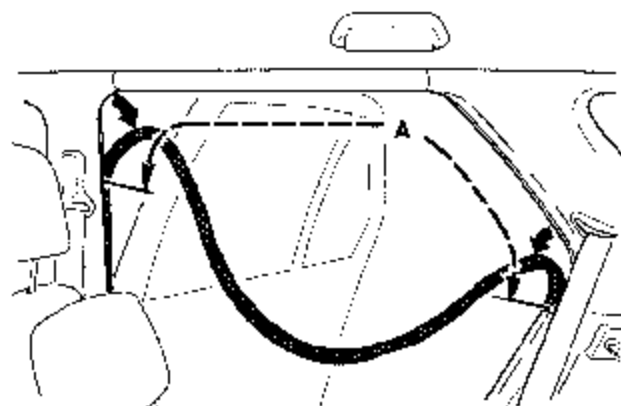
4. Remove the three screws holding the bottom of the rear quarter window trim panel. Do not attempt to remove the trim panel yet.
5. Remove the door opening seal in area "A" as shown below.

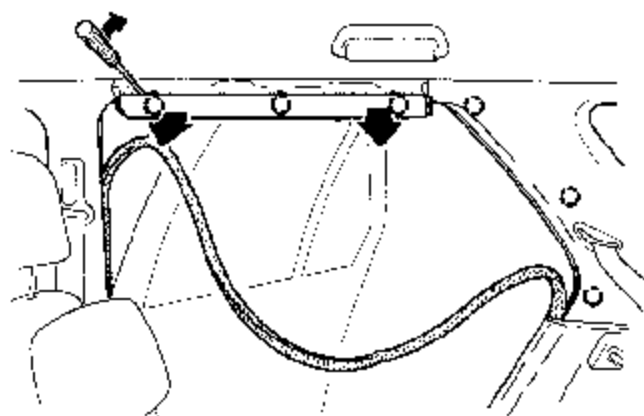
6. Loosen the six clips; then remove the rear roof side trim.

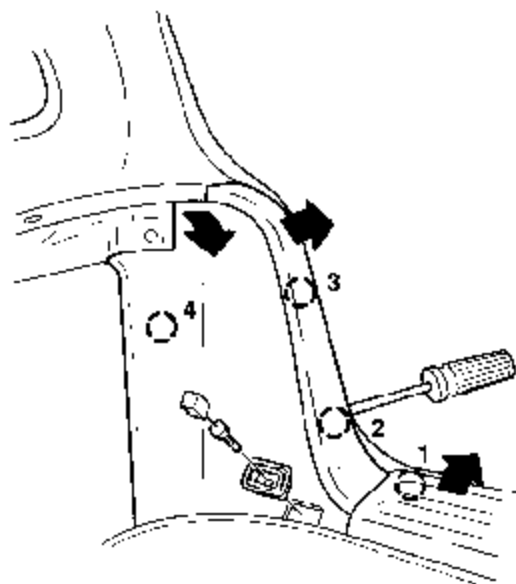
7. Loosen the clips on the outside edges of the rear trim panel. Loosen the clips on the rear corner trim. Remove the rear tie-down hooks.

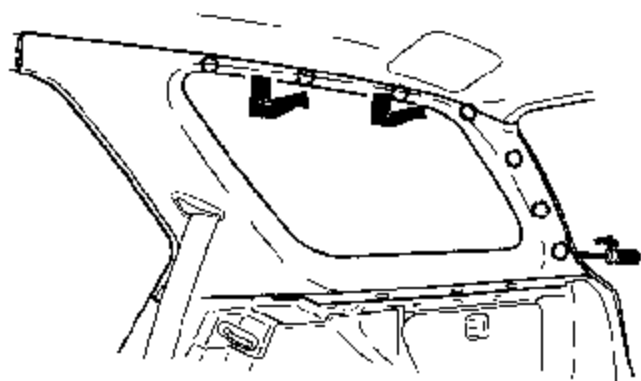
8. Starting at the rear, loosen the clips holding the quarter window trim panel.

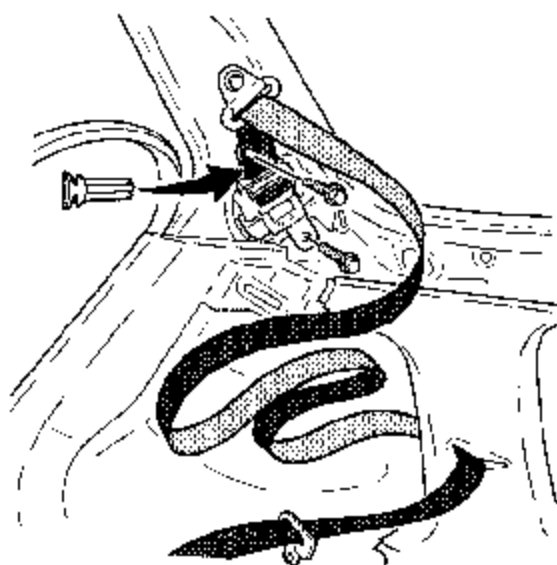
9. Remove the quarter window trim panel by holding it along the front edge and pulling it down and out. After removing, verify that all the clips are still attached to the trim panel.
10. Pull the seat belt fully out of the retractor. Hold it in the unretracted position by installing the clamp (from the kit) across the webbing.
11. Remove the two retractor assembly mounting bolts.

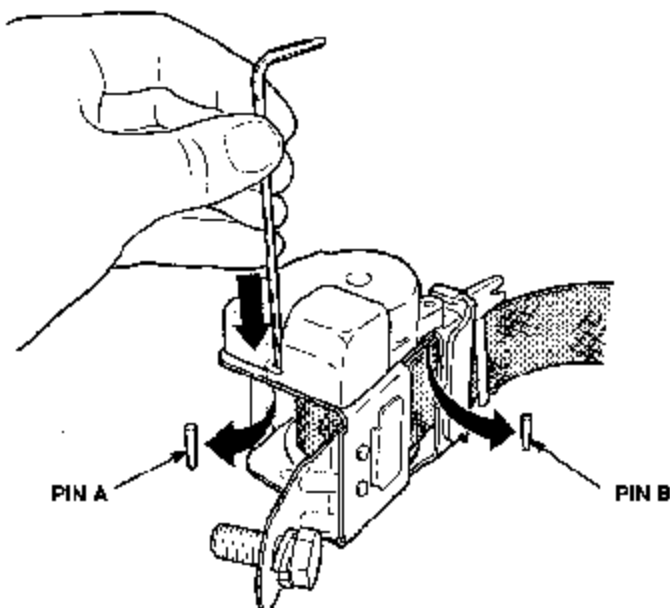
12. Place the retractor assembly on a flat surface with the blue cover facing up. Use a small allen wrench to push pins A and B through the cover. Locate the pins and discard them. Do not leave the pins in the retractor, they could affect its operation.

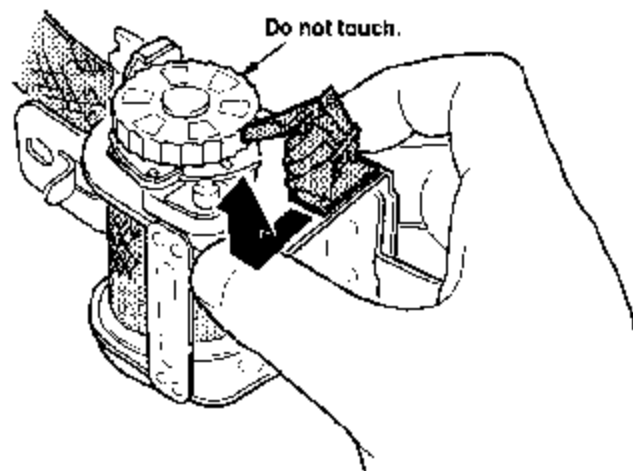
14. Slide the sensor unit to the left to unlatch it from the retractor body. Lift it straight up. Do not touch the flywheel gear.

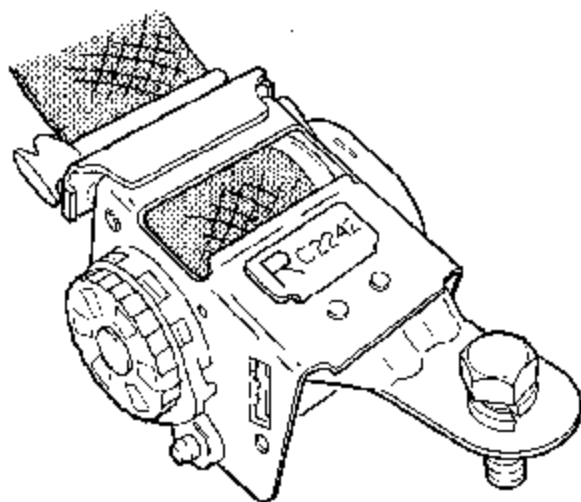
15. Look for the R or L stamped on the retractor assembly to verify that it is right or left. Match this with the color code of the replacement sensor assembly.

NOTICE Check the color code carefully. The retractor will not work properly if the wrong sensor is installed.

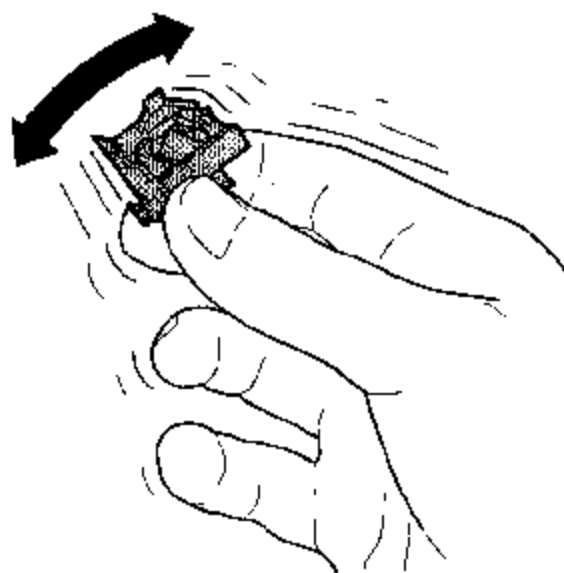
16. Shake the new sensor unit gently. Make sure the actuator and weight move freely. Do not touch the actuator or the weight.

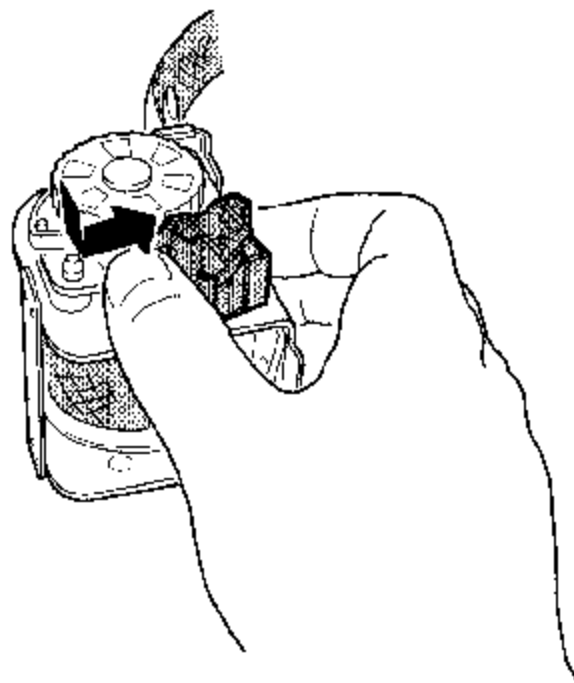
17. Place the new sensor in the slot in the retractor assembly. Slide it to the right to lock it in place. Make sure the sensor is against the end of the slot.

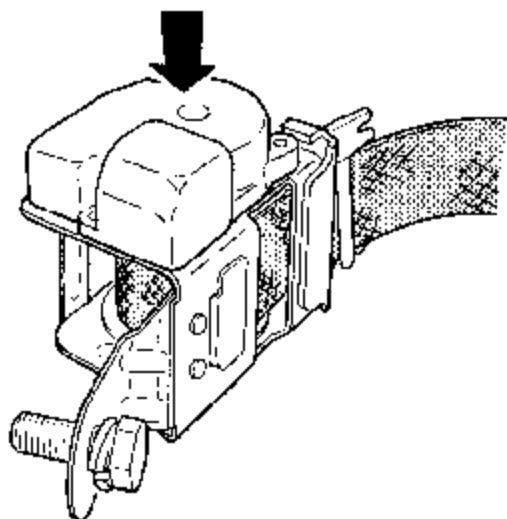
18. Set the new cover in place on the retractor assembly. Align the pins on the cover with the holes in the retractor; then push the cover down to set it in place. Make sure all sides of the cover are seated against the retractor.

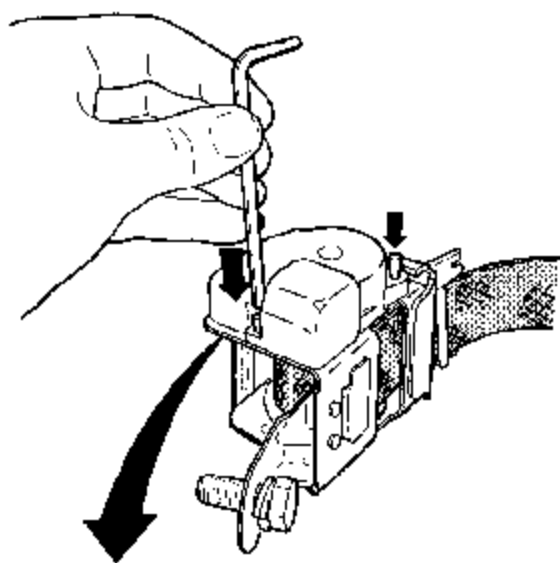
19. Use a 6 mm allen wrench to push down pins A and B and lock the cover in place.

Push pins A and B until they are flush with the cover.

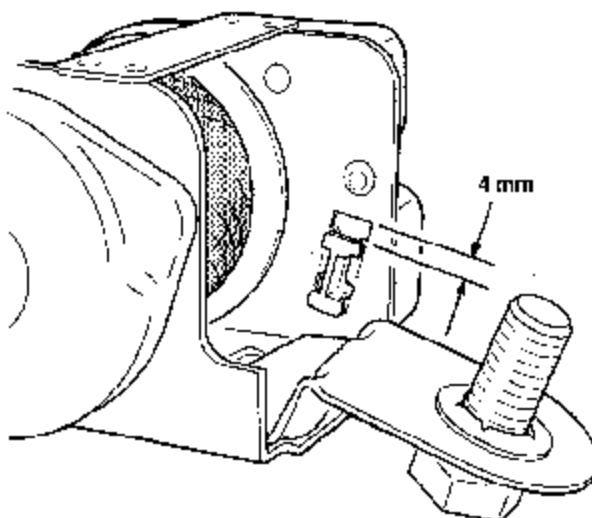
20. Measure the sensor unit gap. If it is less than 3.5 mm, slide the sensor unit into place with your finger. The gap should be as close to 4 mm as possible.

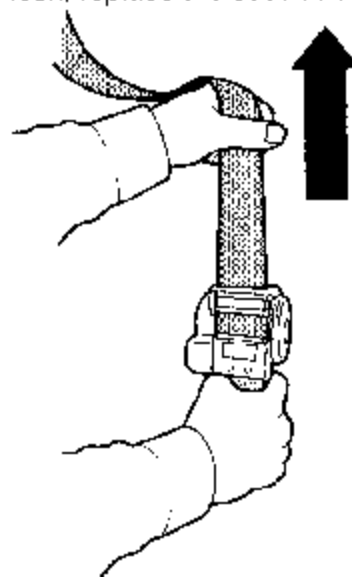
21. Remove the clamp from the seat belt. Allow the belt to slowly go back into the retractor. Make sure the webbing is not twisted.
22. Hold the retractor assembly vertically. Pull the belt out slowly and verify that it locks. If the belt fails to lock, replace the seat belt assembly.

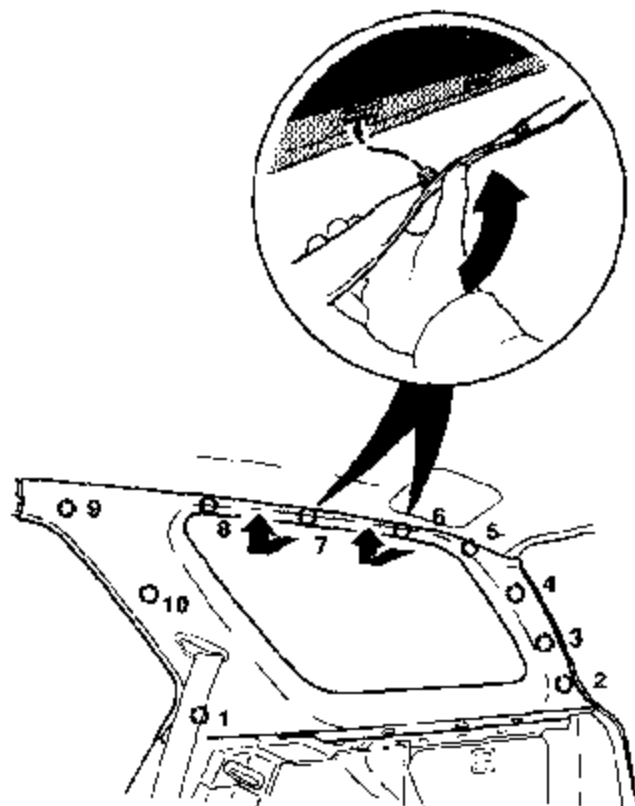
- Verify that all clips are connected to each trim piece before installing.
- To install the rear quarter window trim panel, seat clip 1 first. Seat clip 2 next followed by the remaining clips.
- To seat clips 6 and 7, slightly twist the upper section of the trim panel.

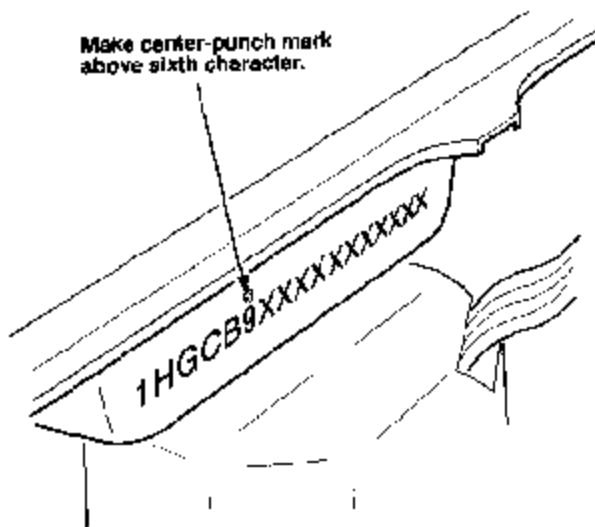
27. Center-punch a completion mark above the sixth digit of the engine compartment VIN.

Make center-punch mark
above sixth character.

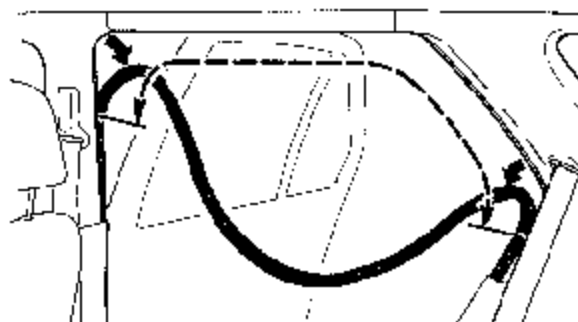
3. Remove the seat-back side cushion mounting bolt. Remove the seat-back side cushion by sliding it upward.
4. Fold the rear seat-back forward.
5. Remove the screw from the rear pillar trim panel. Remove the top screw from the side seal trim.
6. Remove the door opening seal in the area shown.

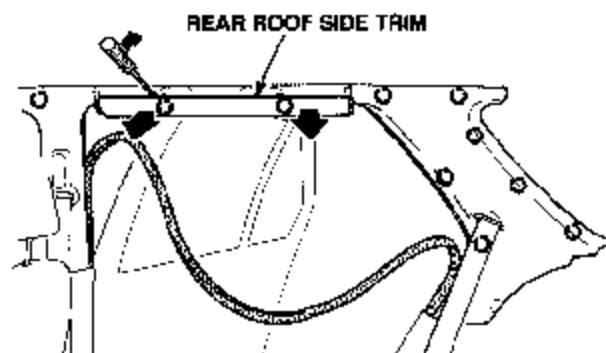
7. Loosen the six clips; then remove the rear roof side trim.

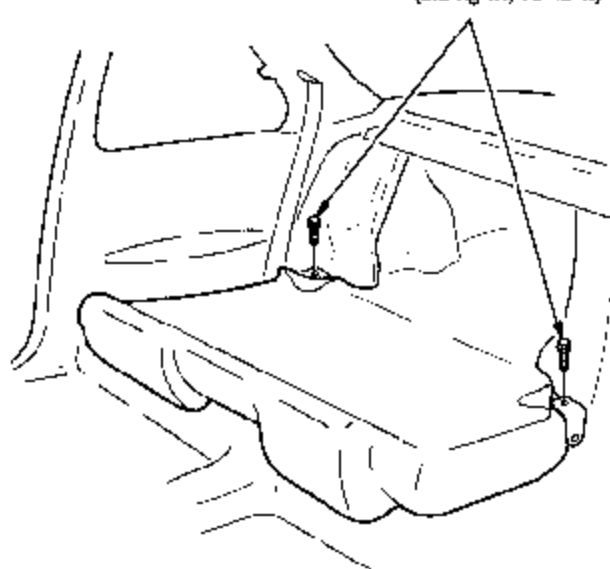
10. Move the front seats forward. Fold the seat-backs forward.
11. Remove the rear seat cushion mounting bolt. Remove the rear seat cushion.
12. Remove the left and right grab rails (EX only). Do not lose the spacer washers.
13. Open the trunk and fold the rear seat-back forward. Loosen the carpet from the trunk floor. Remove the two seat-back mounting bolts and remove the seat-back.
 - Do not place any weight on the seat-back while removing the mounting bolts.

22 N-m
(2.2 kg-m, 16 lb-ft)

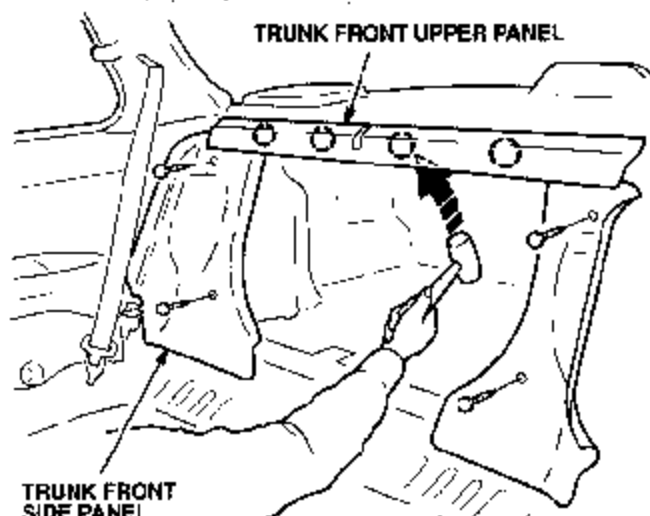
14. Loosen the trunk front upper panel by tapping the clips with a plastic hammer. Remove the panel.

15. Use a trim removal tool to remove the trunk front side panel pins. Remove the side panel.

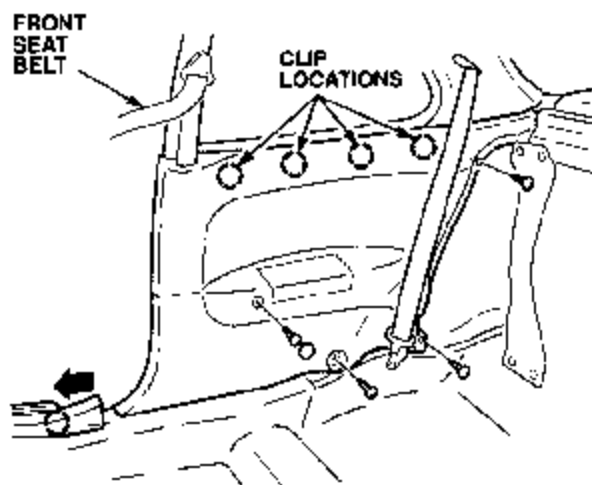
16. Remove the small round cap in the rear quarter trim panel arm rest. Remove the four screws holding the quarter panel.
17. Unlatch the rear window. Remove the cover; then remove the rear window latch mounting screws. Note the position of the latch on the screws for reinstallation.
18. Pull the front of the door sill molding up, and slide it forward to remove it.
19. Starting at the rear, gently pull the rear quarter trim panel outward to loosen the clips. Remove the trim panel by moving it forward and sliding it along the front seat belt.

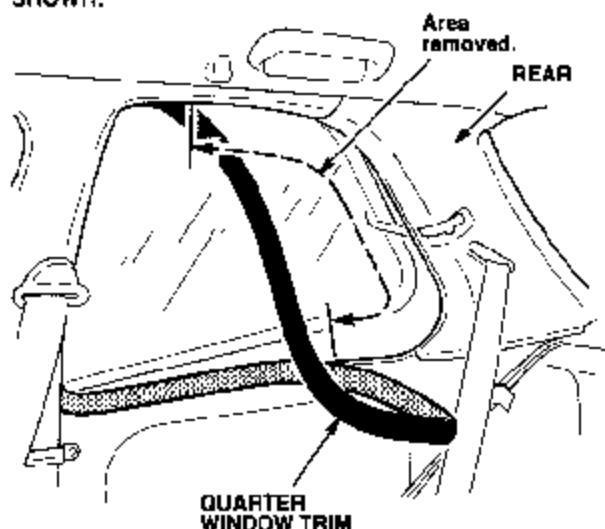
20. Remove the quarter window trim in the area shown.

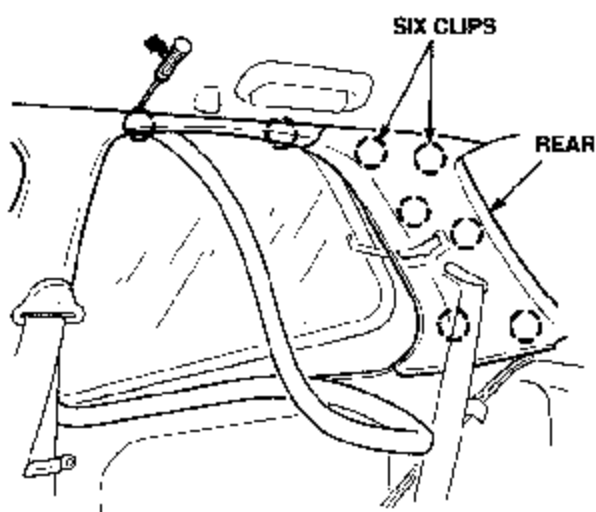
21. Loosen two clips on the window upper trim. Loosen six clips on the rear pillar trim panel. Remove the panel.

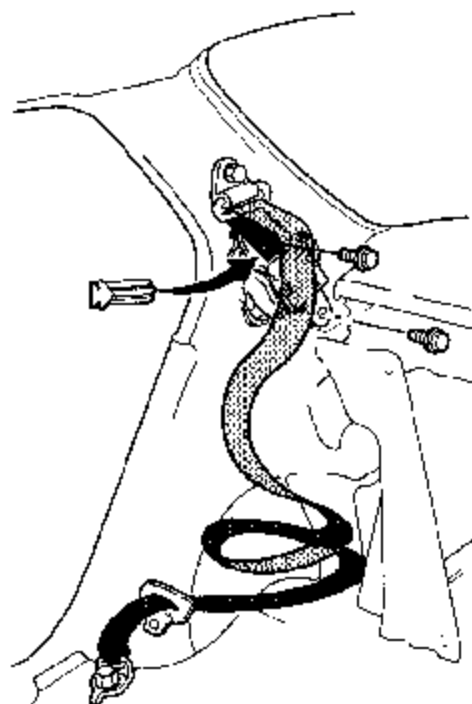
23. Pull the seat belt fully out of the retractor. Hold it in the unreeled position by installing the clamp (from the kit) across the webbing.
24. Remove the two retractor assembly mounting bolts.

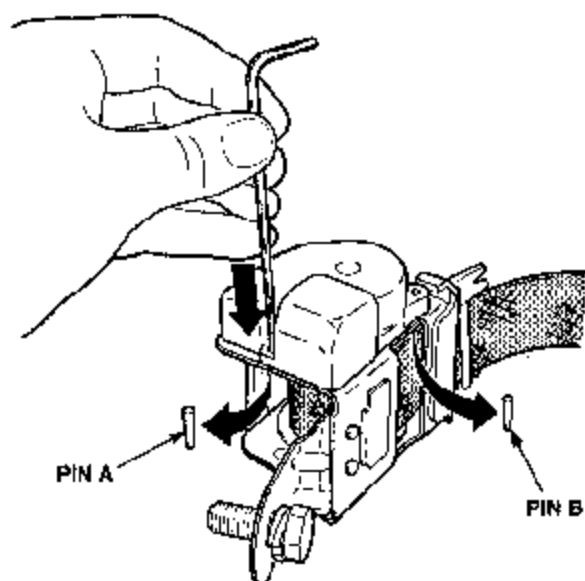
25. Place the retractor assembly on a flat surface with the blue cover facing up. Use a small allen wrench to push pins A and B through the cover. Locate the pins and discard them. Do not leave the pins in the retractor, they could affect its operation.

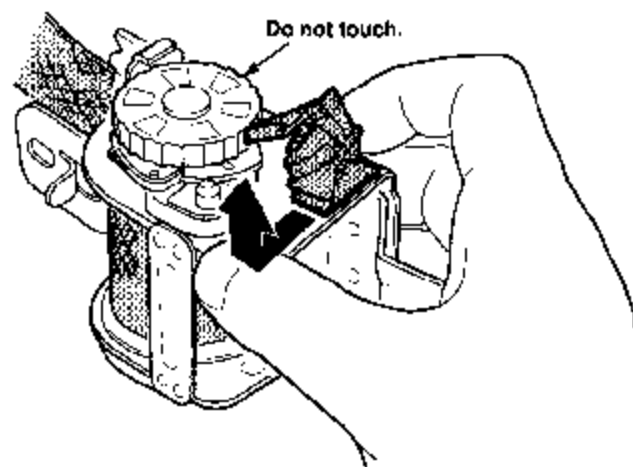
27. Slide the sensor unit to the left to unlatch it from the retractor body. Lift it straight up. Do not touch the flywheel gear.

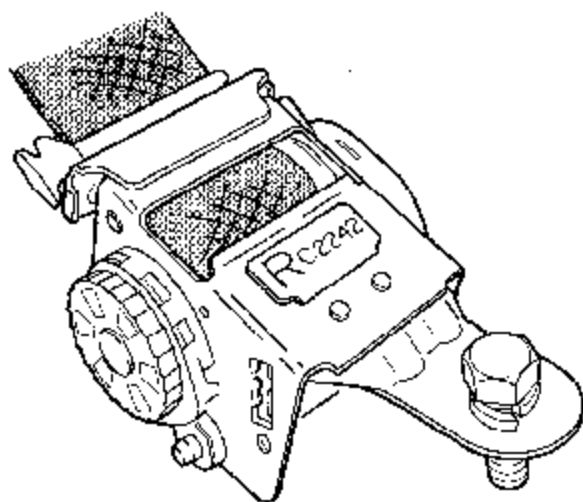
28. Look for the R or L stamped on the retractor assembly to verify that it is right or left. Match this with the color code of the replacement sensor assembly.

NOTICE Check the color code carefully. The retractor will not work properly if the wrong sensor is installed.

Sensor Housing

R	Red
L	Yellow

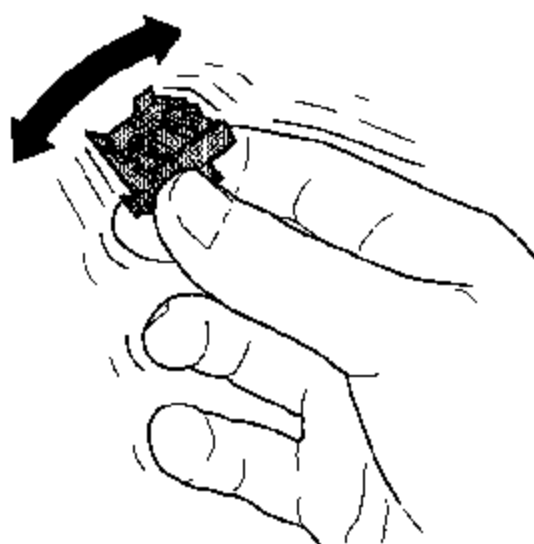
29. Shake the new sensor unit gently. Make sure the actuator and weight move freely. Do not touch the actuator or the weight.

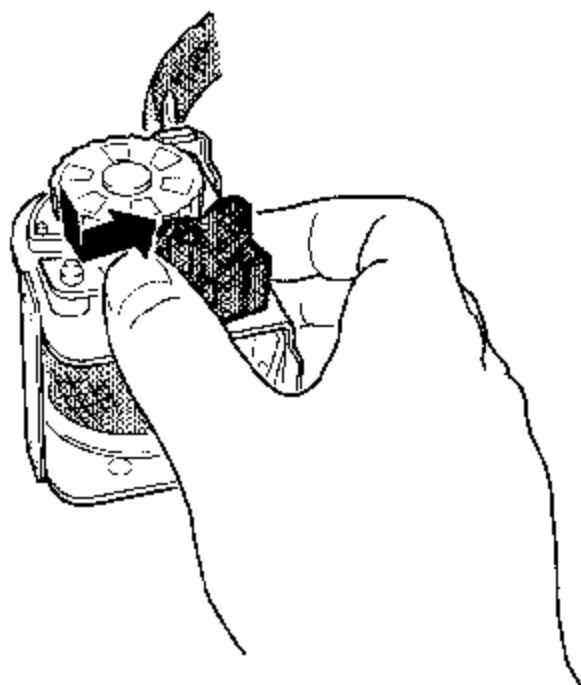
30. Place the new sensor in the slot in the retractor assembly. Slide it to the right to lock it in place. Make sure the sensor is against the end of the slot.

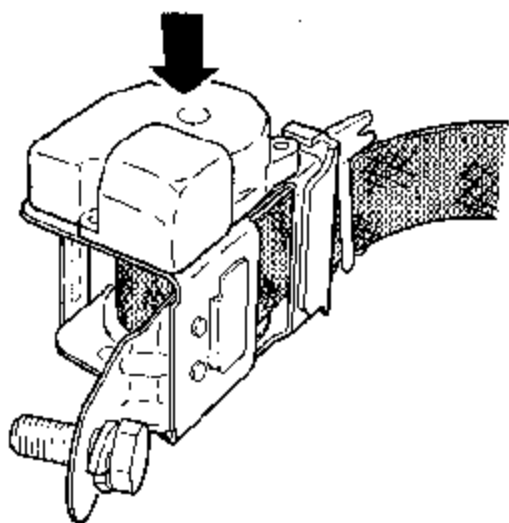
31. Set the new cover in place on the retractor assembly. Align the pins on the cover with the holes in the retractor; then push the cover down to set it in place. Make sure all sides of the cover are seated against the retractor.

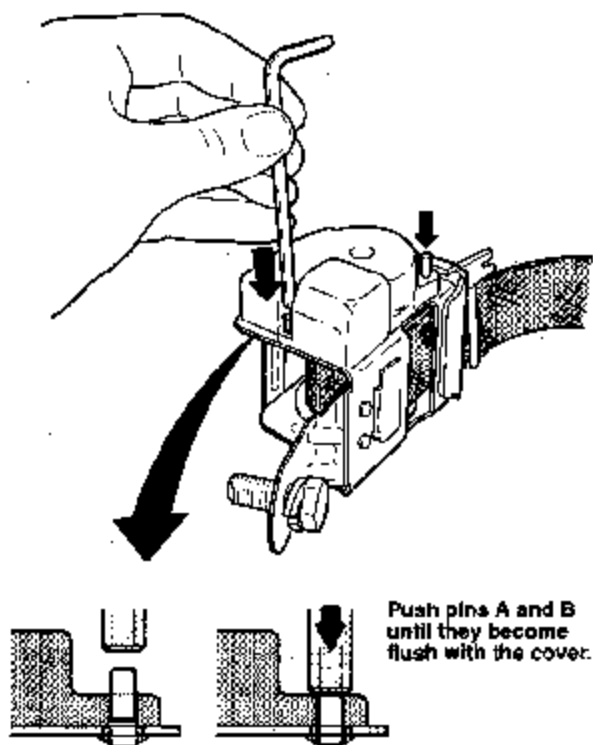
32. Use a 6 mm allen wrench to push down pins A and B and lock the cover in place.

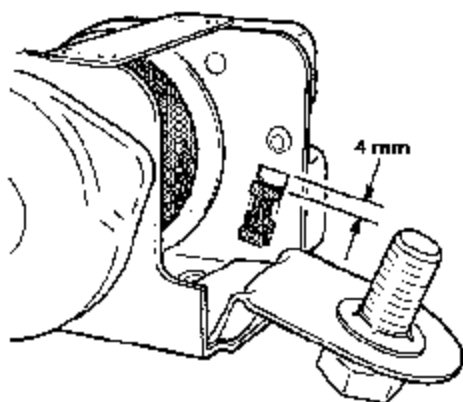
33. Measure the sensor unit gap. If it is less than 3.5 mm, slide the sensor unit into place with your finger. The gap should be as close to 4 mm as possible.

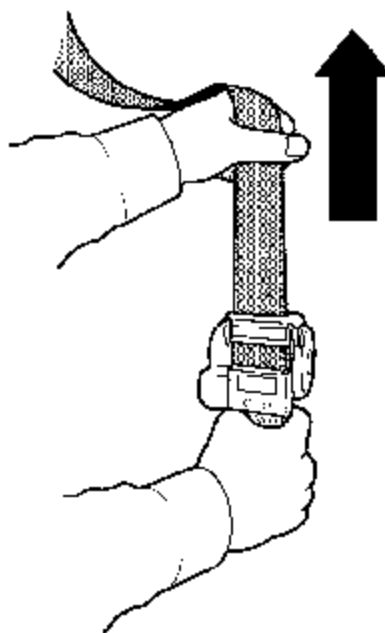
34. Remove the clamp from the seat belt. Allow the belt to slowly go back into the retractor. Make sure the webbing is not twisted.
35. Hold the retractor assembly vertically. Pull the belt out slowly and verify that it locks. If the belt fails to lock, replace the seat belt assembly.

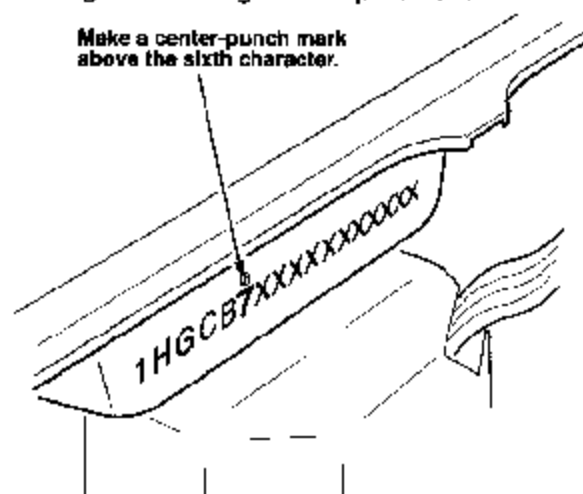
40. Center-punch a completion mark above the sixth digit of the engine compartment VIN.

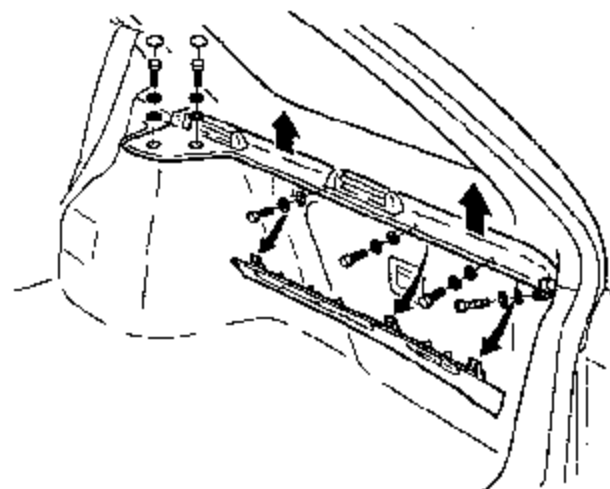
3. Remove the side rail trim (three clips). Remove six 6 mm bolts; then remove the side rail.

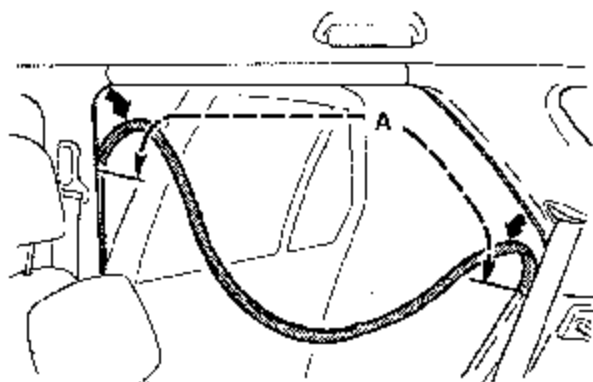
4. Remove the three screws holding the bottom of the rear quarter window trim panel. Do not attempt to remove the trim panel yet.
5. Remove the door opening seal in area "A" as shown below.

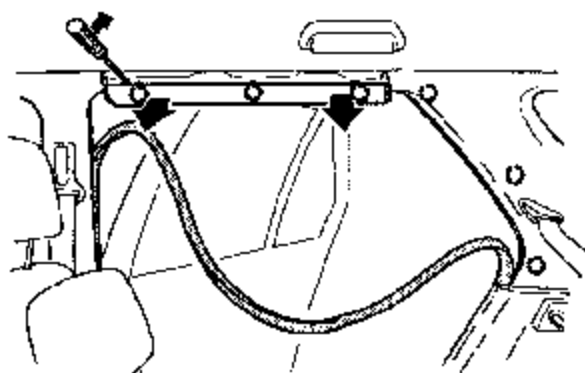
6. Loosen the six clips; then remove the rear roof side trim.

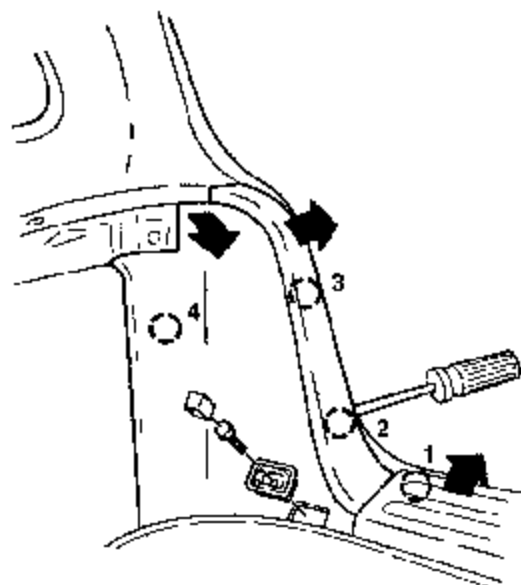
7. Loosen the clips on the outside edges of the rear trim panel. Loosen the clips on the rear corner trim. Remove the rear tie-down hooks.

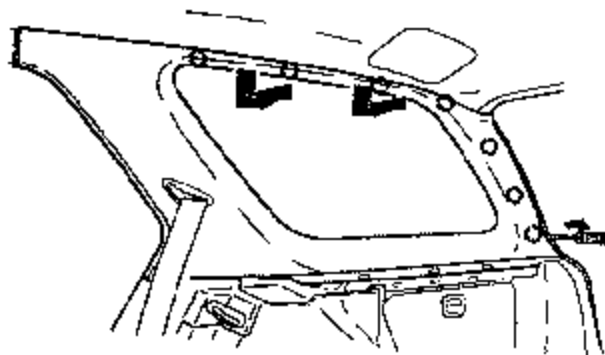
8. Starting at the rear, loosen the clips holding the quarter window trim panel.

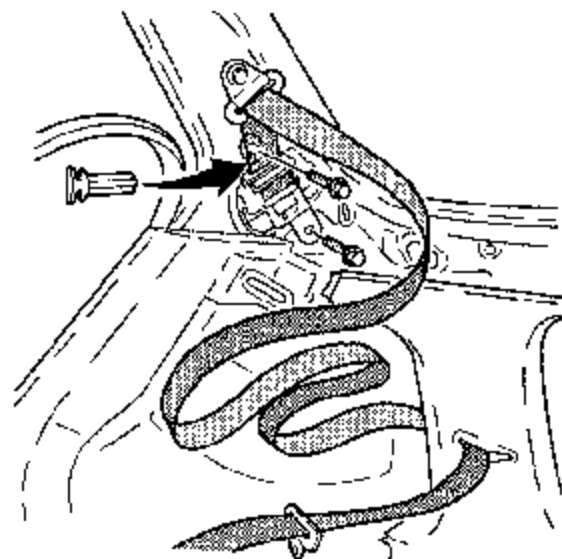
11. Remove the two retractor assembly mounting bolts.

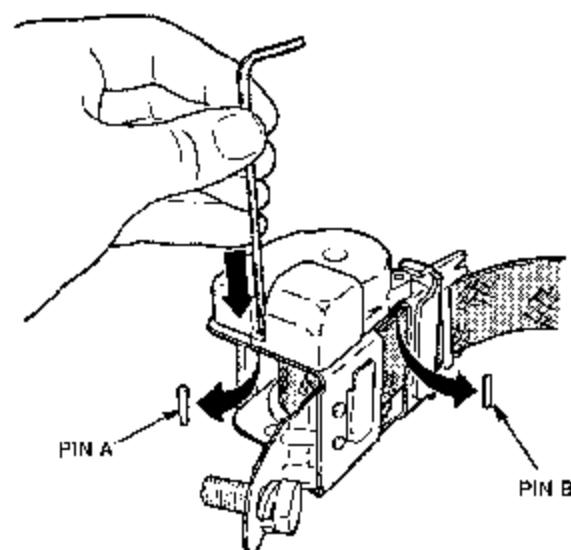
12. Place the retractor assembly on a flat surface with the blue cover facing up. Use a small allen wrench to push pins A and B through the cover. Locate the pins and discard them. Do not leave the pins in the retractor; they could affect its operation.

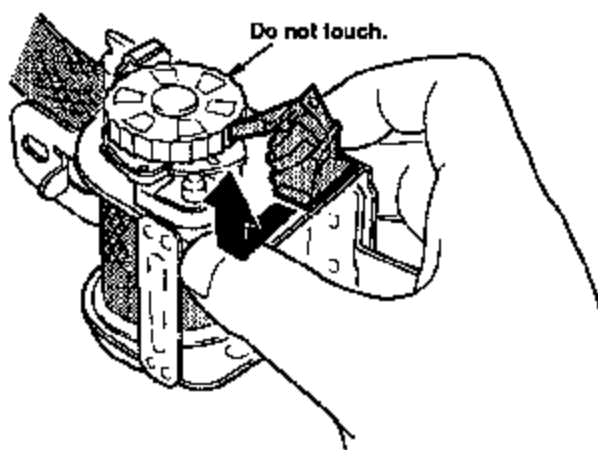
14. Slide the sensor unit to the left to unlatch it from the retractor body. Lift it straight up. Do not touch the flywheel gear.

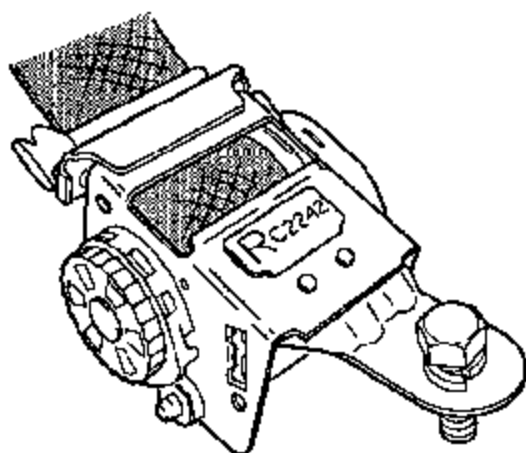
Sensor Housing

15. Look for the R or L stamped on the retractor assembly to verify that it is right or left. Match this with the color code of the replacement sensor assembly.

R	Green
L	Brown

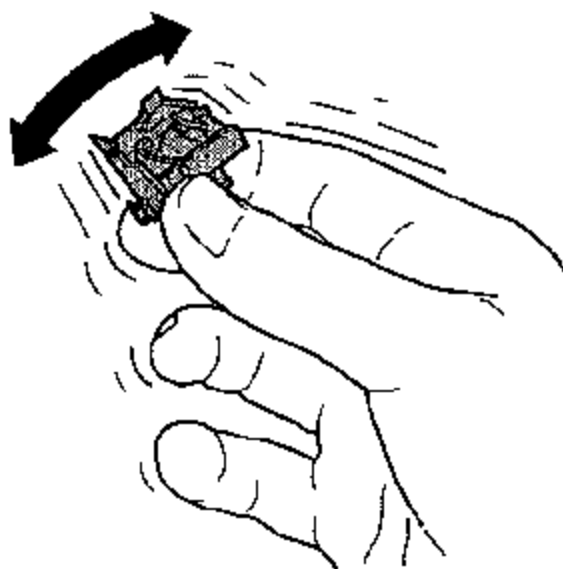
16. Shake the new sensor unit gently. Make sure the actuator and weight move freely. Do not touch the actuator or the weight.

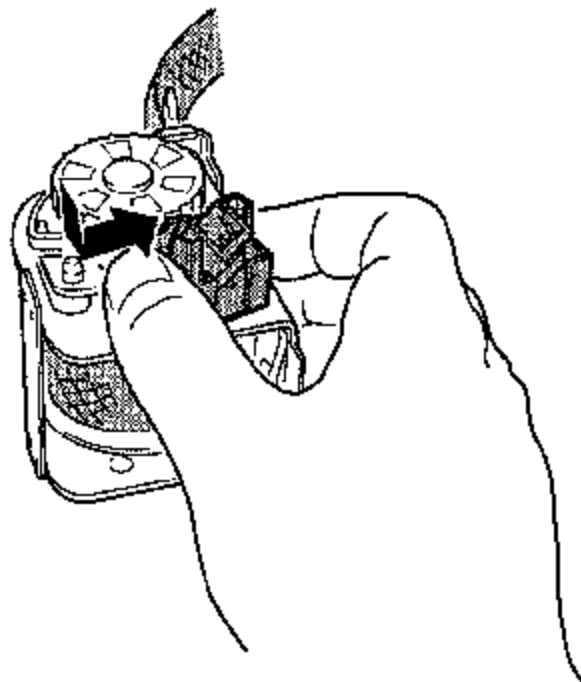
17. Place the new sensor in the slot in the retractor assembly. Slide it to the right to lock it in place. Make sure the sensor is against the end of the slot.

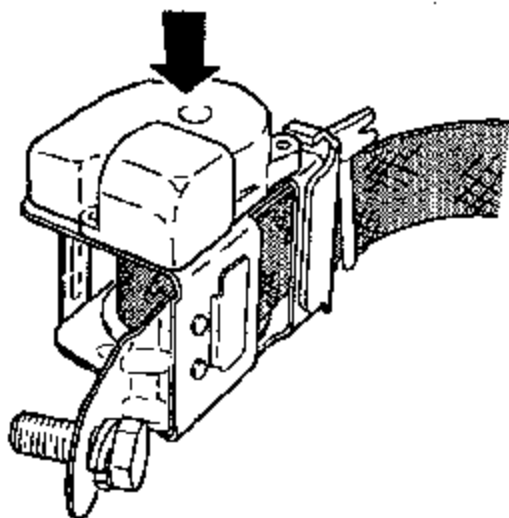
18. Set the new cover in place on the retractor assembly. Align the pins on the cover with the holes in the retractor; then push the cover down to set it in place. Make sure all sides of the cover are seated against the retractor.

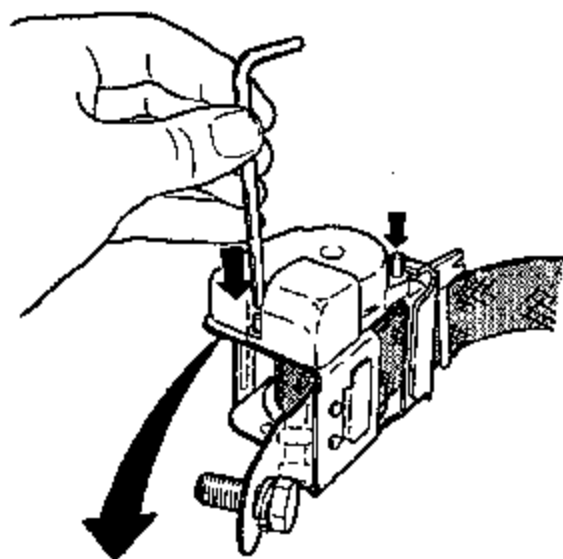
19. Use a 6 mm allen wrench to push down pins A and B and lock the cover in place.

Push pins A and B until they are flush with the cover.

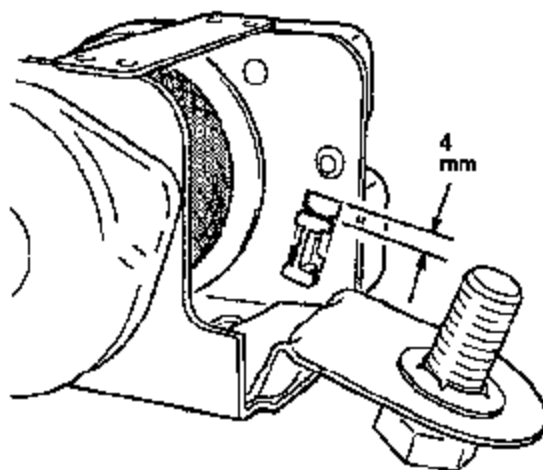
20. Measure the sensor unit gap. If it is less than 3.5 mm, slide the sensor unit into place with your finger. The gap should be as close to 4 mm as possible.

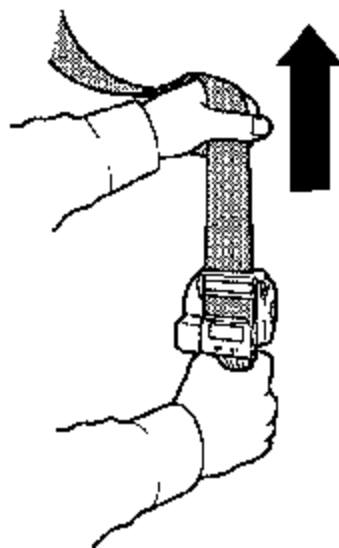
22. Hold the retractor assembly vertically. Pull the belt out slowly and verify that it locks. If the belt fails to lock, replace the seat belt assembly.

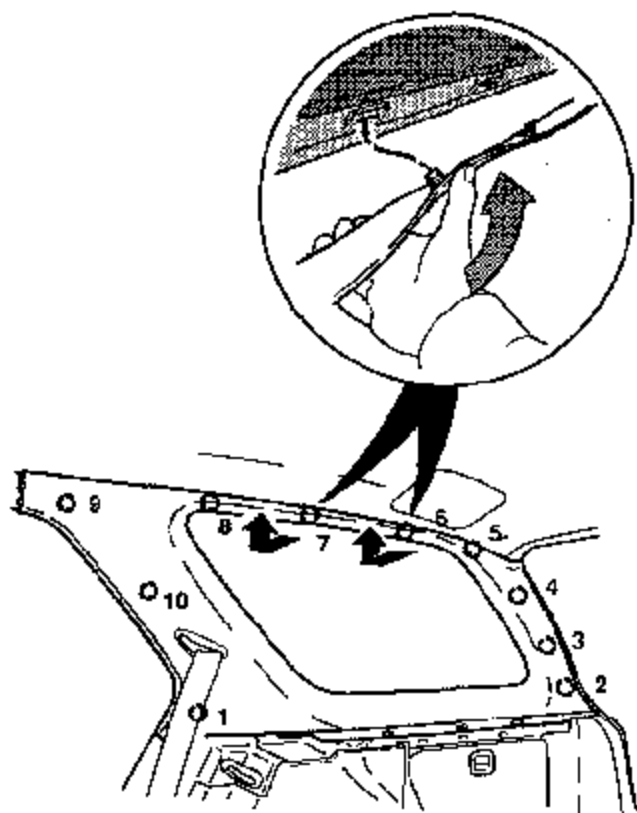
- Verify that all clips are connected to each trim piece before installing.
- To install the rear quarter window trim panel, seat clip 1 first. Seat clip 2 next followed by the remaining clips.
- To seat clips 6 and 7, slightly twist the upper section of the trim panel.

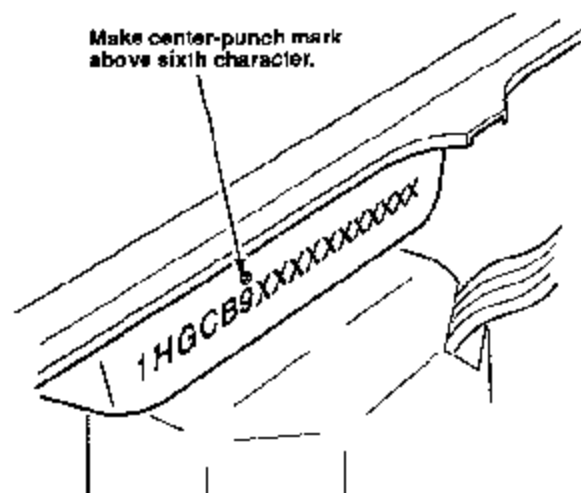
27. Center-punch a completion mark above the sixth digit of the engine compartment VIN.
